EXTERNAL WASTE MANAGEMENT LICENCE COMPLIANCE AUDIT REPORT: ENVIROSERV – SHONGWENI LANDFILL SITE

June 2019

TITLE: External Environmental Audit Report: Waste Management Licence conditions for EnviroServ – Shongweni Landfill Site

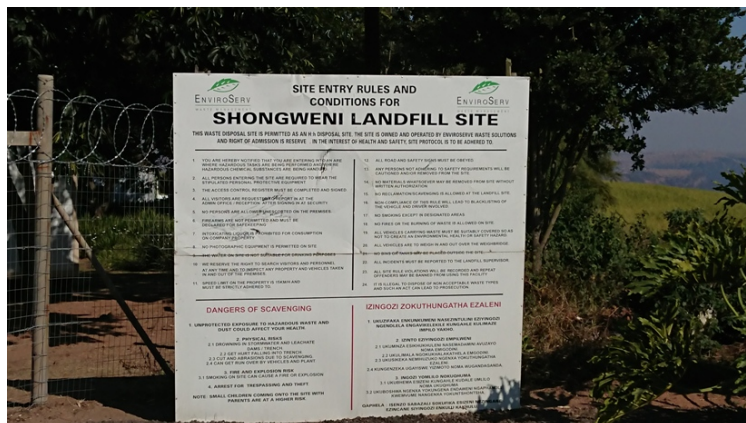
Plate 1: Signage

The site complies with the signage requirements. Durable weatherproof signs are put up at the main gate for both the landfill and the treatment plant. The site is also fenced and regular patrols are conducted to ensure any damage to site is fixed as a matter of urgency. Twenty four hour security is present at the gate. Language requirements are also complied with. Plates 1 and 2 shows the signage at the entry to the site.

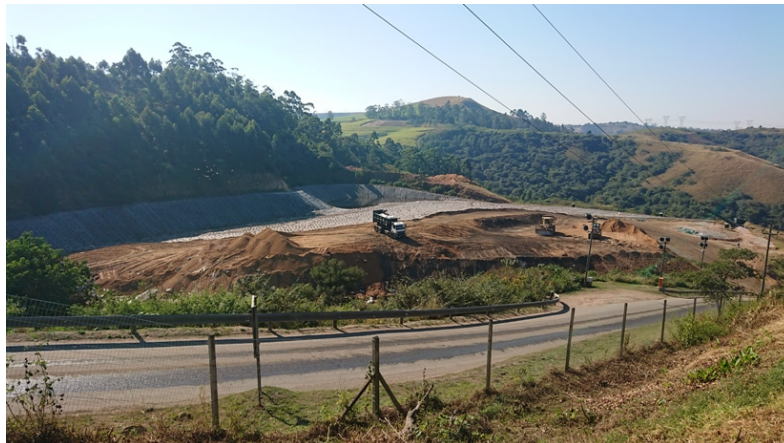
Plate 3: Plastic lining of cells to prevent ingress of rainwater

Plastic covers were placed over the active cell to prevent ingress of rain water. This gets removed as the cell is being used again.

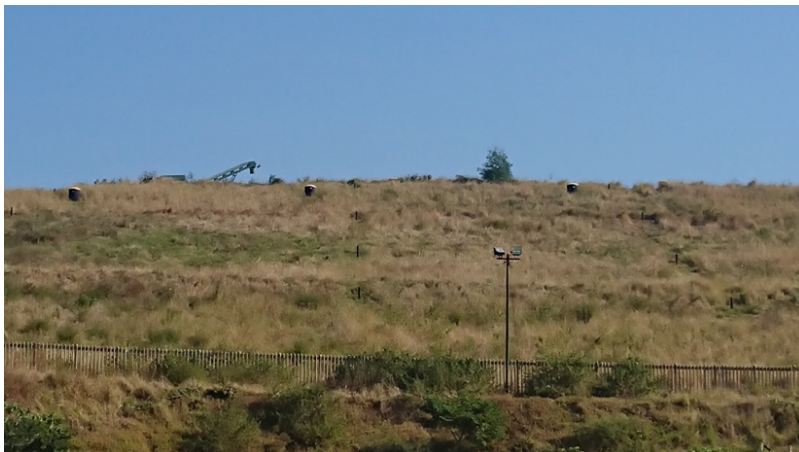
Plate 4: Vegetated side slopes of the cells

The slopes of the sides of the site has been constructed to prevent erosion. During the audit the successful results of hydro-seeding the slopes could be seen. Please see plate 4 of the vegetated side slopes of cell 2

The slopes are inspected for erosion on a monthly basis by Ground Water Monitoring Services. A report is generated for each inspection.

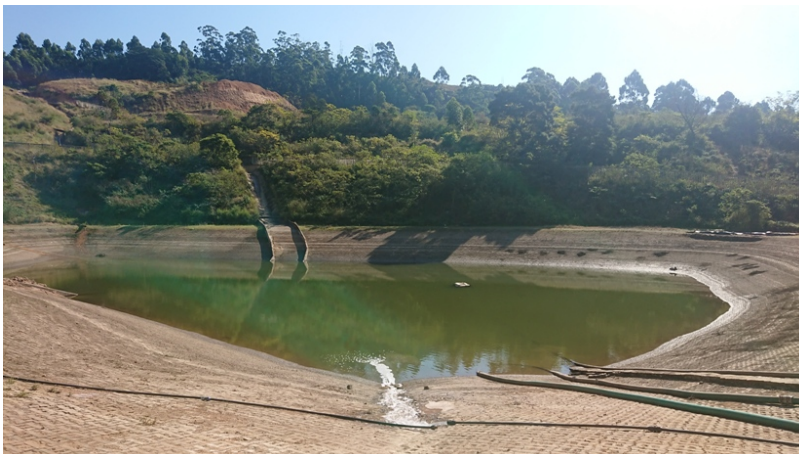
Plate 5: Contaminated storm water collection pond. Valley 2

Contaminated storm water collection facilities meet the stated requirements and can handle the runoff of a one in fifty year storm event. Please see Plate 5 of the one of the contaminated storm water ponds that collects and stores contaminated storm water generated on site. A significant storm occurred on the 22nd of April 2019 which did cause the storm water structures to overflow. Please see **Appendix H** and the discussion under paragraph 5.4.2. The dams are currently being emptied. Contaminated storm water is trucked via road tanker to the Southern Waste Water Treatment Plant. Please see **Appendix G** for the permit to discharge the contaminated storm water.

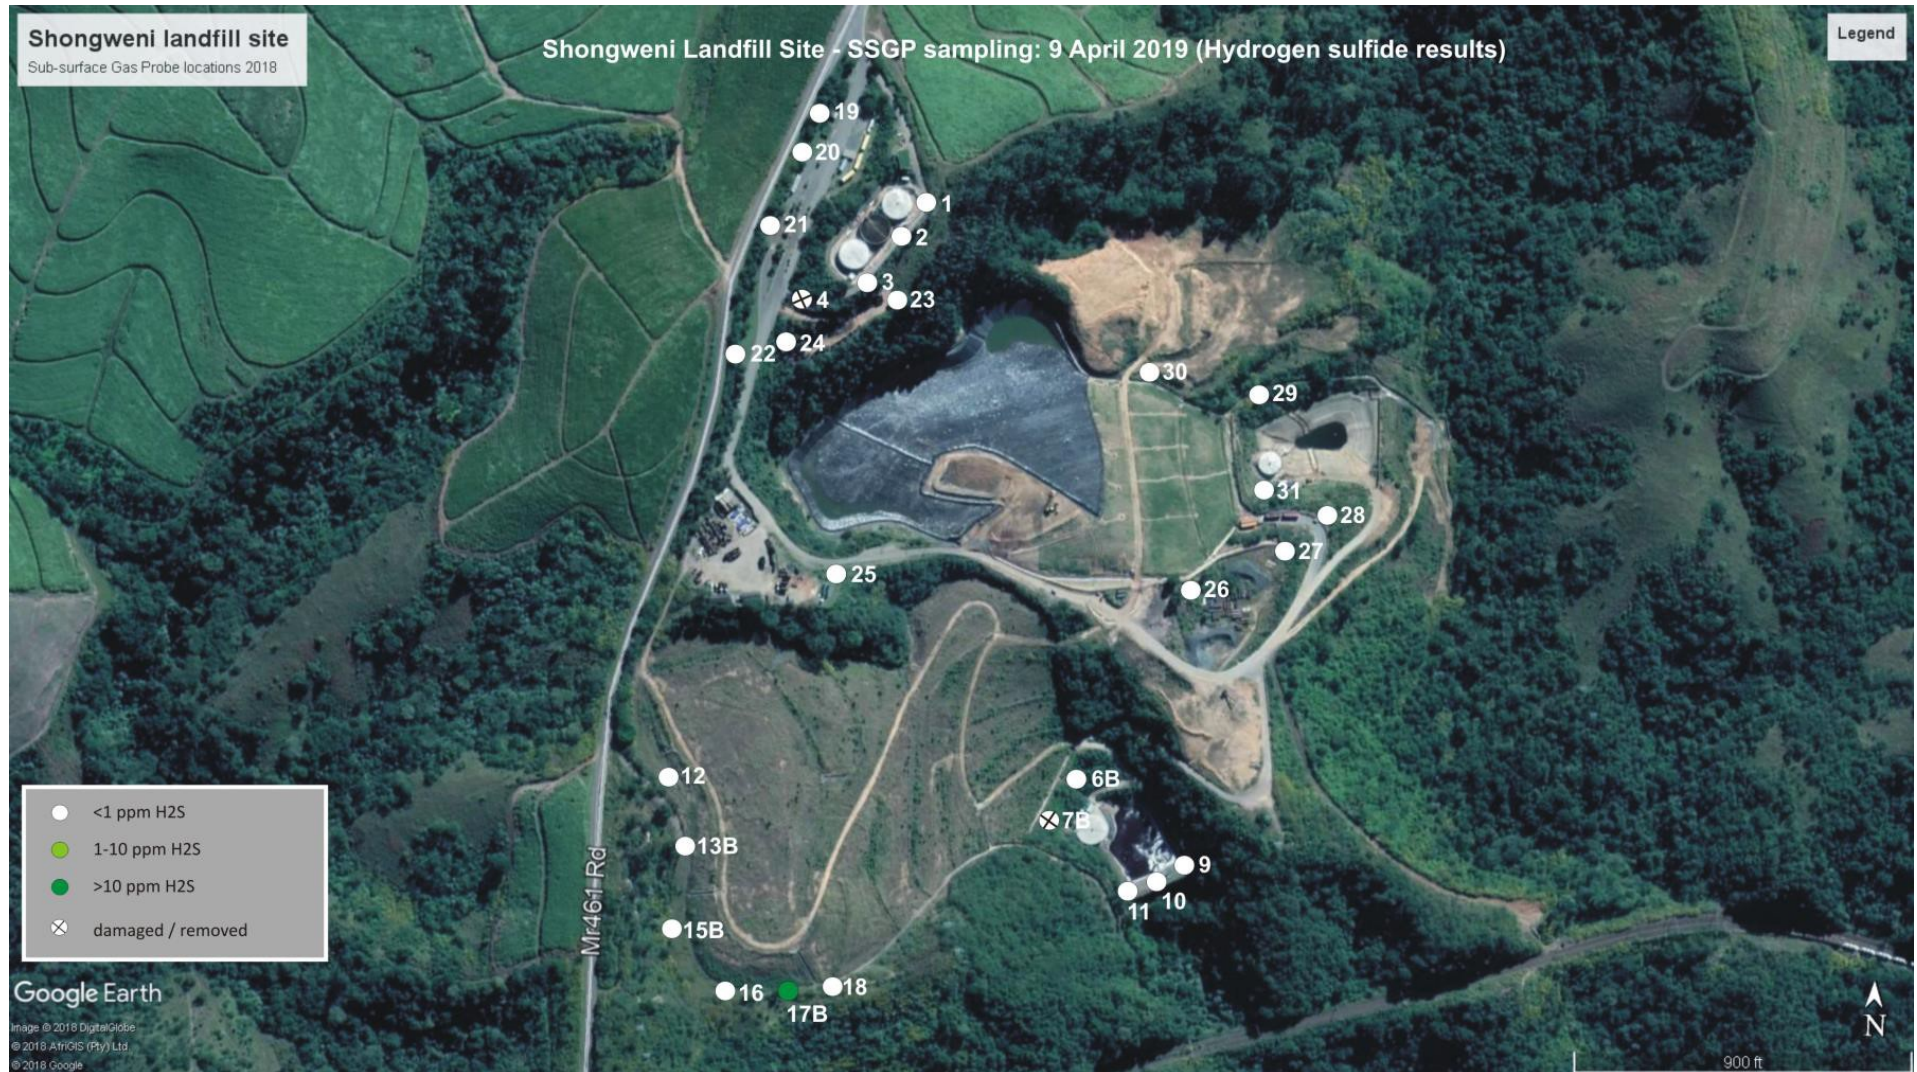
Figure 1: Positions of the gas probes

PROBE NO	PARAMETER						
	CH4 %	CO2 %	O2 %	H2S (ppm)	LEL %	Flow (l/h)	AP (mb)
Date: 2019/04/09							
1	0	0.1	20.9	0	0	0.1	948
2	0	0.9	20.1	0	0	0.1	948
3	0	0.2	20.7	0	0	0.1	948
6B	0	0.4	20.3	0	0	0.1	960
9	0	0.1	20.7	0	0	0.1	960
10	0	0.1	20.6	0	0	0.1	960
11	0	0.1	20.7	0	0	0.1	960
12	0	0.1	21.3	0	0	0.1	952
13B	41	27.3	6.6	0	100	0.1	952
15B	0	0.2	21.1	0	0	0.1	952
16	0	0.1	21.3	0	0	0.1	952
17B	20.1	11.3	11.9	38	100	0.1	952
18	0	0.1	21.3	0	0	0.1	952
19	0	0.3	20.5	0	0	0.1	948
20	0	0.6	20.2	0	0	0.1	948
21	0	0.1	20.5	0	0	0.1	948
22	0	0.1	19.8	0	0	0.1	948
23	0	0.3	20.6	0	0	0.1	948
24	0	0.5	20.8	0	0	0.1	948
25	0	0.1	21.1	0	0	0.1	959
26	0	0.2	21	0	0	0.1	959
27	0	0.2	20.9	0	0	0.1	959
28	0	0.1	20.8	0	0	0.1	959
29	0	0.2	20.6	0	0	0.1	959
30	0	0.1	21	0	0	0.1	959
31	0	0.5	20.3	0	0	0.1	959
