EXTERNAL WASTE LICENCE COMPLIANCE AUDIT REPORT: ENVIROSERV – SHONGWENI LANDFILL SITE

August 2018

TITLE: External Environmental Audit Report: Waste Licence conditions for EnviroServ – Shongweni Landfill Site

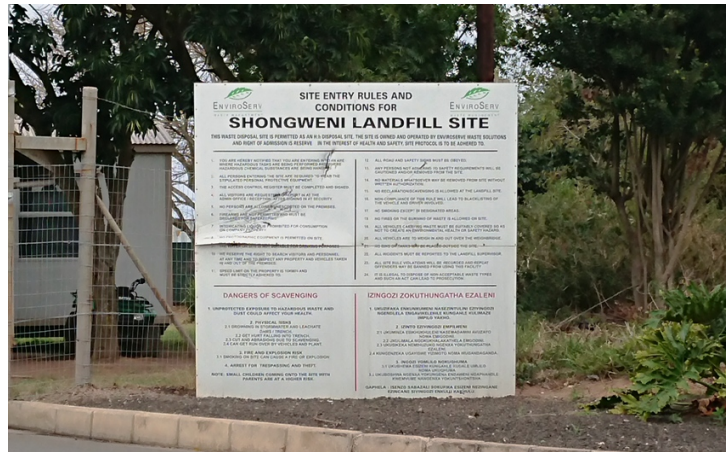
Plate 1: Signage

The site complies with the signage requirements. Durable weatherproof signs are put up at the main gate for both the landfill and the treatment plant. The site is also fenced and regular patrols are conducted to ensure any damage to site is fixed as a matter of urgency. Twenty four hour security is present at the gate. Language requirements are also complied with. Plates 1 and 2 shows the signage at the entry to the site.

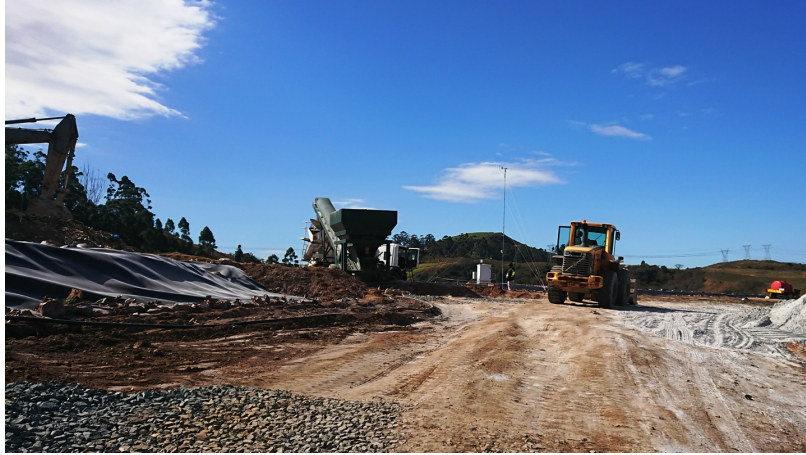
Plate 3: Mobile Micro-encapsulation plant

No further construction or development of the cells and structures of the waste sites took place but a mobile Micro Encapsulation batching plant was deployed two weeks (6 August 2018) prior to the audit – this mobile encapsulation plant was deployed following the appeal decision of 9 December 2012 against the suspension of the Waste Management Licence by the minister of Environmental affairs (Hon Dr B E E Molewa) n Annexure A, paragraph 1.2 states: "The brine from the leachate treatment plant can be disposed of onto the working face provided it is microencapsulated."

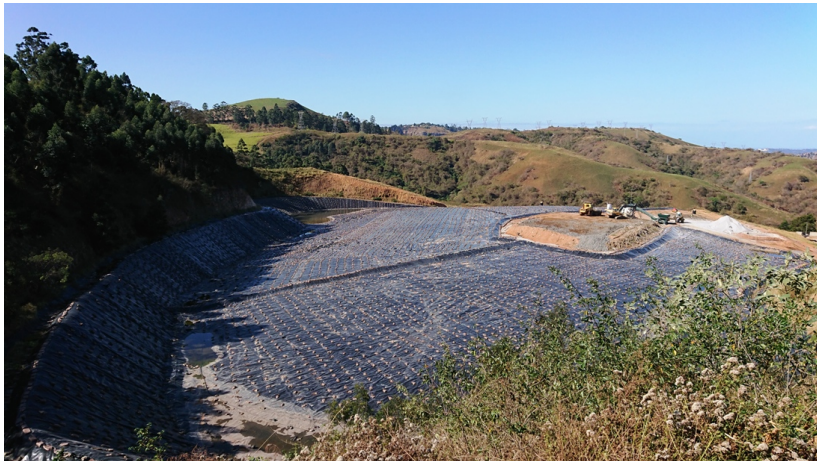
Plate 4: Plastic lining of cells to prevent ingress of rainwater

Plastic lining of all cells took place to prevent ingress of rain water. This is a temporary measure that will be removed once waste is received again.

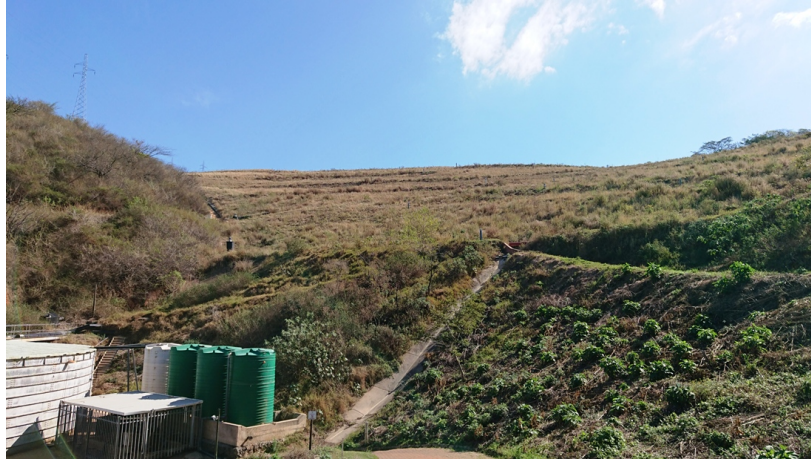
Plate 5: Vegetated side slopes of the cells

Jones and Wagener confirmed to the Department that the construction was carried out as specified in their designs and proof of this submission was available to the auditor during the audit. The last updated slope stability report from Jones and Wagener Report is dated 21st July 2018. The site was constructed in accordance with recognised engineering practice with special consideration to stability and to the approved plan. The slopes of the sides of the site has been constructed to prevent erosion. During the audit the successful results of hydro-seeding the slopes could be seen.

The slopes are inspected for erosion on a monthly basis by Ground Water Monitoring Services. A report is generated for each inspection.

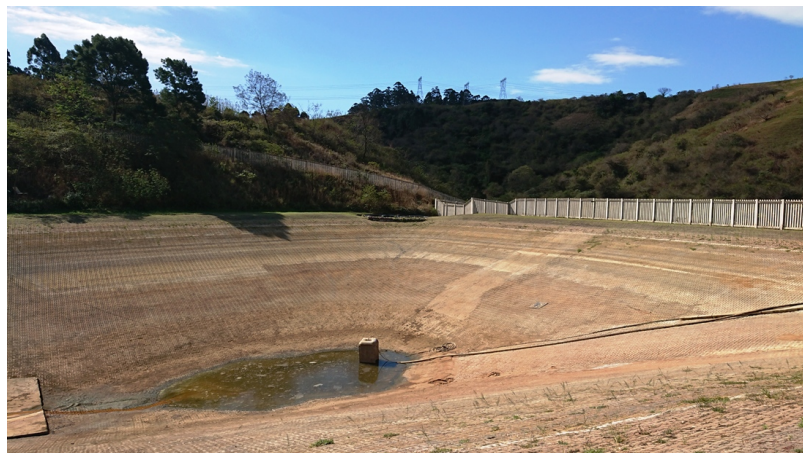
Plate 6: Empty Contaminated storm water collection pond. Valley 2

Contaminated storm water collection facilities meet the stated requirements and can handle the runoff of a one in fifty year storm event. Please see Plate 6 of the contaminated storm water pond that collects and stores all contaminated storm water generated on site.

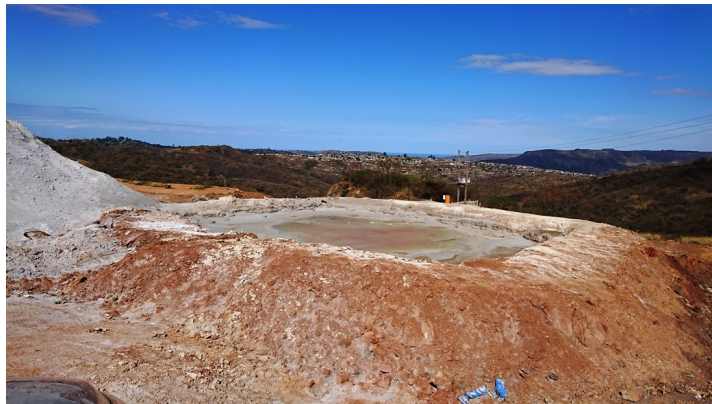
Plate 7: Lime injection process

Leachate (generated by valley 1 (small volume) and valley 2) gets treated by the Leachate Treatment Plant (Number **12/9/11/L467/4**) permeate from this process is used for lime injection for pH adjustment in the waste body, brine is micro-encapsulated in a mobile plant – please see plate 3 of the mobile micro-encapsulation plant. Please see plate 7 of the lime injection process. Lime is injected under hydraulic pressure to correct the pH in the waste body. Contaminated storm water from the collection pond is sent by road tanker to the eThekweni Southern Waste water treatment works. A permit to do dispose was issued on 17 June 2018 and this permit is valid from 1 August 2018 to 31 January 2019. Please see **Appendix G** of the effluent permit.

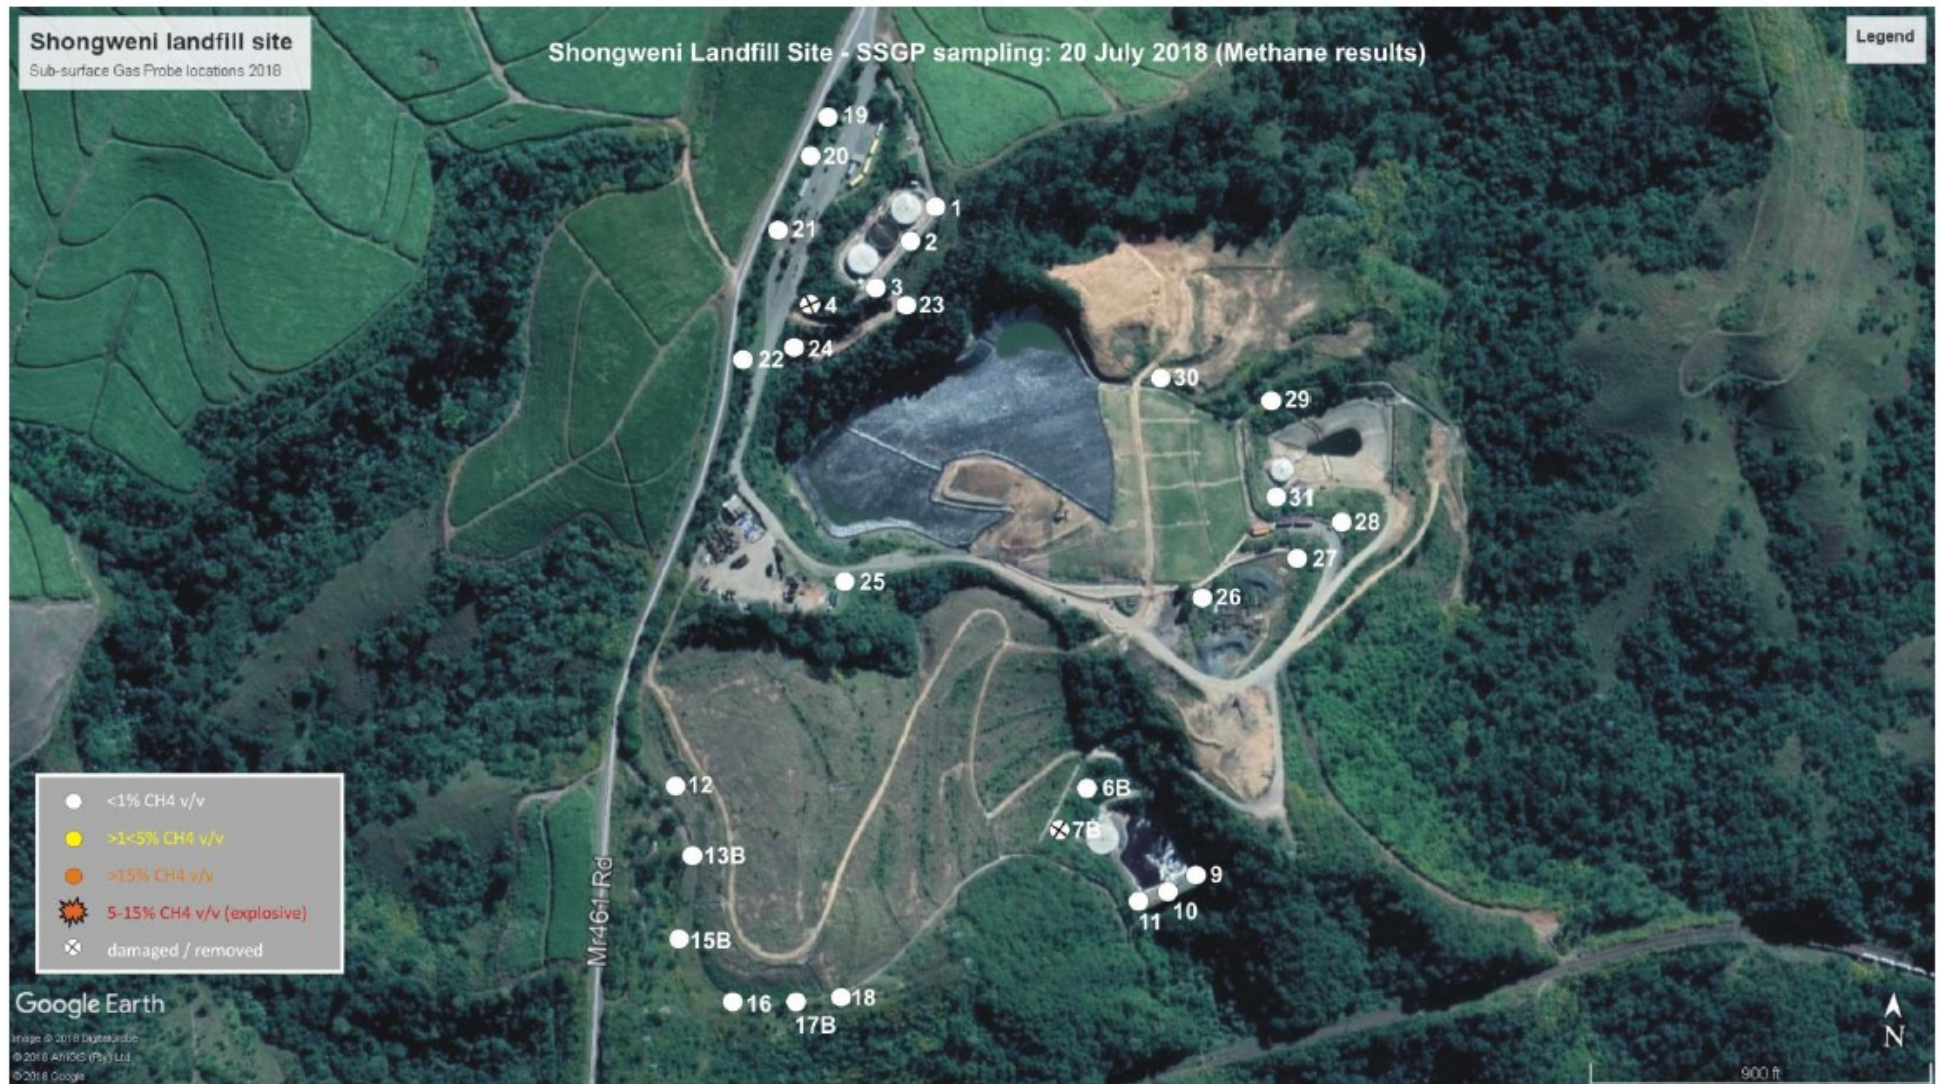
Figure 1: Positions of the gas probes and samples sites

Geozone conducted the monitoring as part of the sub surface gas probes in the landfill site. The latest sampling of LFG within the SSGP was conducted on 20 July 2018. There are currently a total of twenty-six (26) SSGPs installed along the boundaries of the Shongweni landfill site. Probes No 7 and 4 remains damaged and these probes could not be included in the sampling regimen. Given the locations of these probes there is no urgent need to replace or repair them. Figure 1 shows the location of the probes/samples and **Table 1** shows the results for each sample.

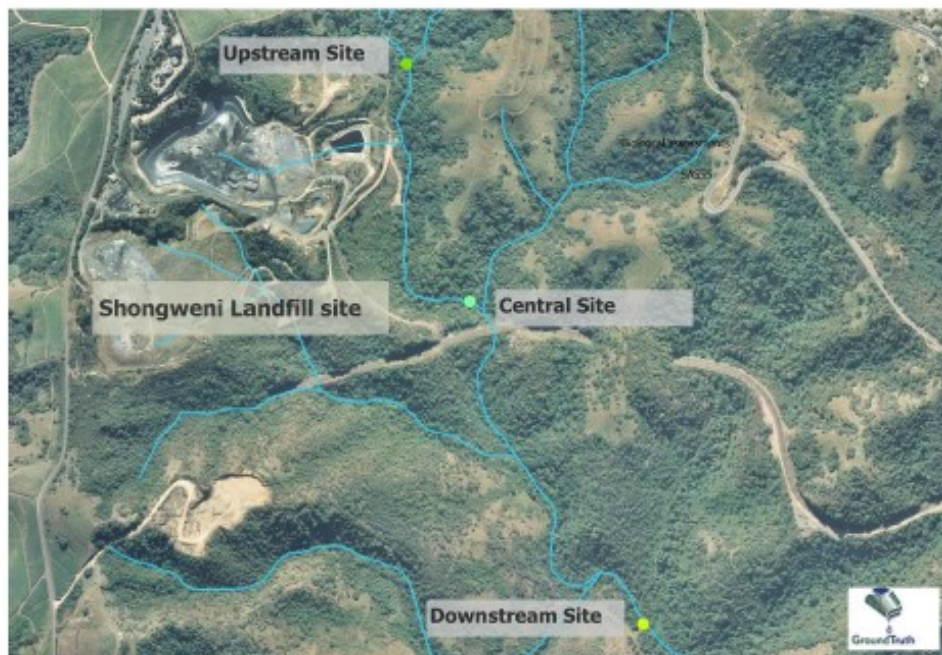
Figure 1-1: Aerial view of the routine biomonitoring sites on the Mgoshongweni Tributary in relation to the EnviroServ Shongweni Landfill site.

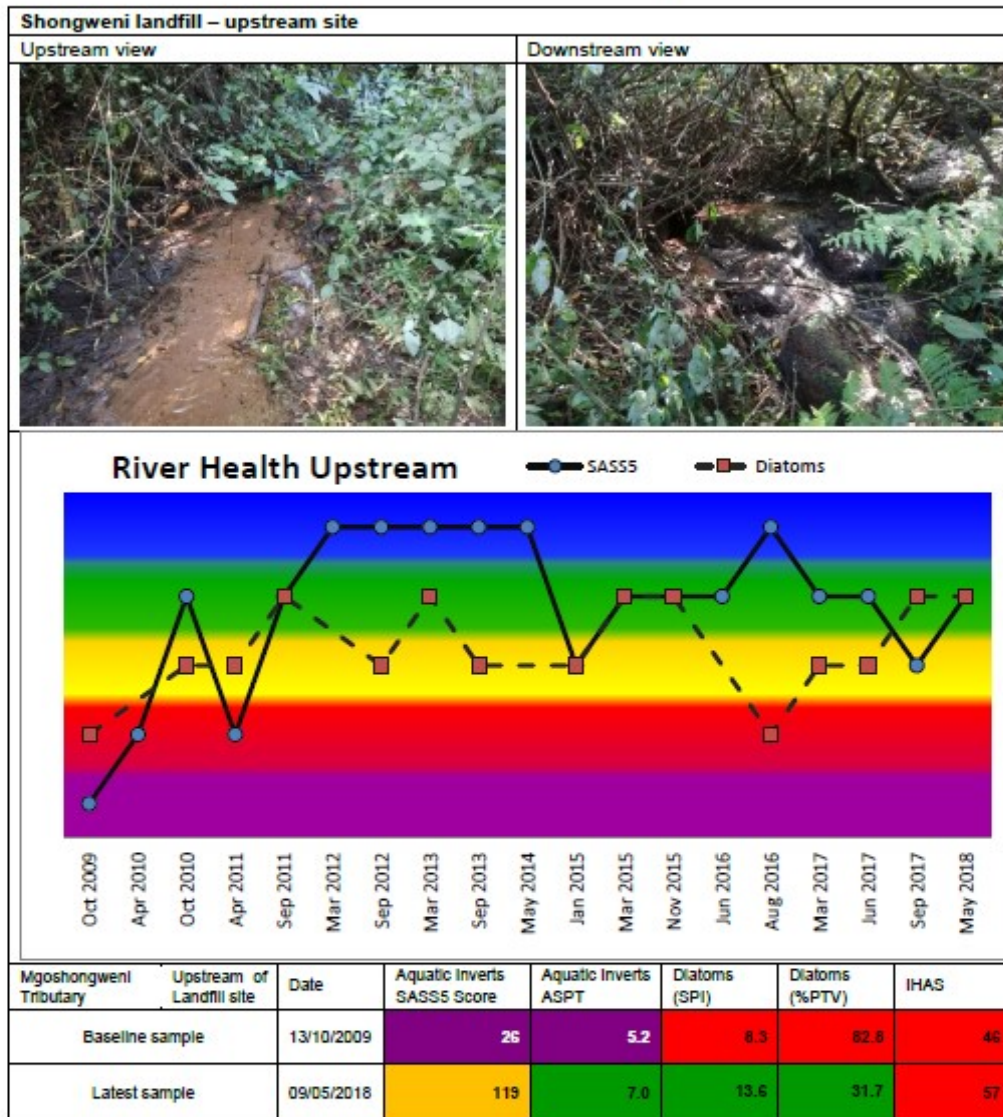
3.1 Summarised river health status of the upstream site

This site is located upstream of the landfill and is surrounded by a mixture of natural and invasive exotic vegetation (e.g. bugweed, castor oil bush and bramble). Due to the dense vegetation and shallow water level at the site, sampling was difficult. However, the biological indicators revealed the site to be in a good condition. There were few taxa found during the SASS5 sampling but several sensitive taxa were present (i.e. Perlidae, Platycnemidae, Philopotamidae and Helodidae) and indicate that the water quality is in a good condition at the

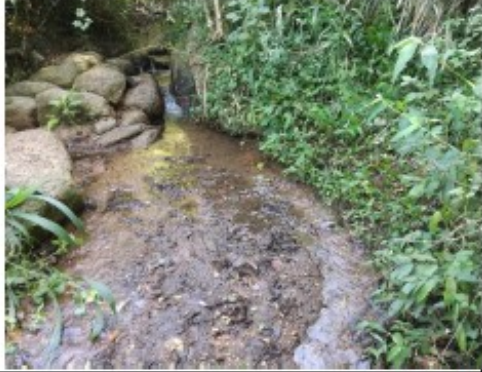
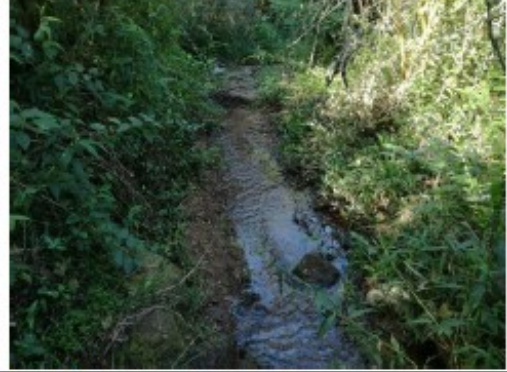
1. Shongweni landfill –site 3							
Upstream view				downstream view

- Sedimentation from upstream and the surrounding valley.
- Potential pollution from the landfill site (including solid waste).
- Alien invasive plants in the riparian areas reducing overall natural diversity and ground cover.

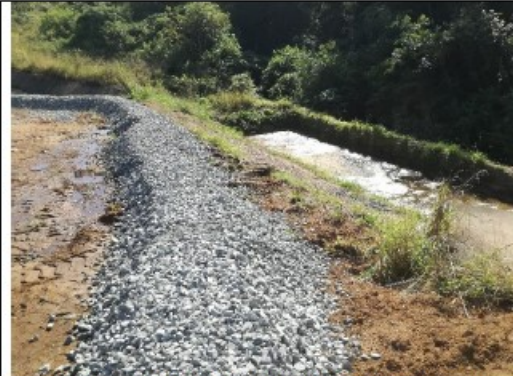
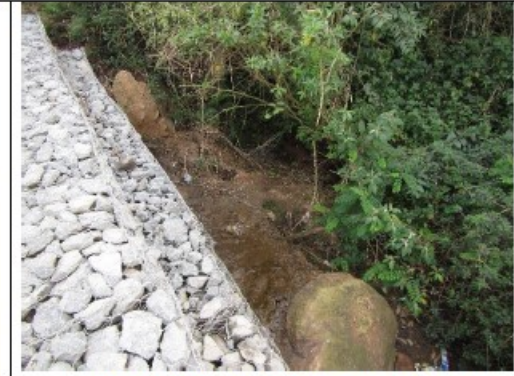
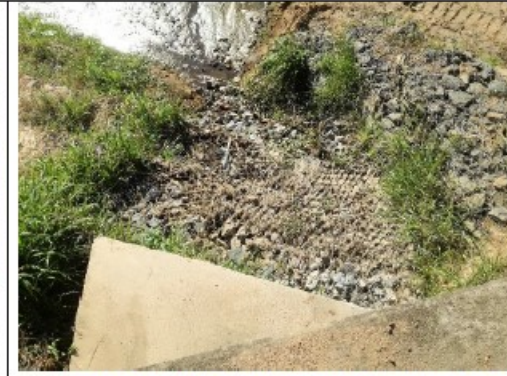
4 General site observations

<p>A) Sand trap has been increased in size and is being maintained. Additional gravel berm in place to reduce run-off</p>	<p>B) New gabion baskets adjacent to sand trap, completed and functioning.</p>	<p>C) Cleaner water entering sand trap. Note no discoloration of concrete drain.</p>
