# **EXTERNAL WASTE MANAGEMENT LICENCE COMPLIANCE AUDIT REPORT: ENVIROSERV – SHONGWENI LANDFILL SITE**

*July 2025*

**TITLE:** External Environmental Audit Report: Waste Management Licence conditions for EnviroServ – Shongweni Landfill Site

**DOREAN REPORT NUMBER:** 07/07/25/ES/EnvAudit\_WML Shongweni WMF

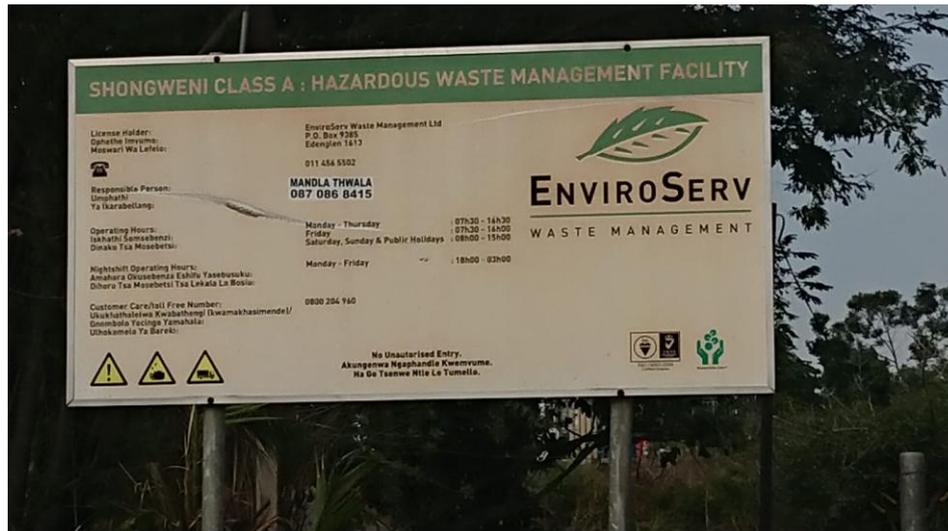
**Plate 1: Signage at the main gate**

The site complies with the signage requirements. Durable weatherproof signs are put up at the main gate for the facility. The site is also fenced and regular patrols are conducted to ensure any damage to site is fixed as a matter of urgency. Twenty four hour security is present at the gate. The local language requirements are also complied with. Please see **Plate 1** of the signage.

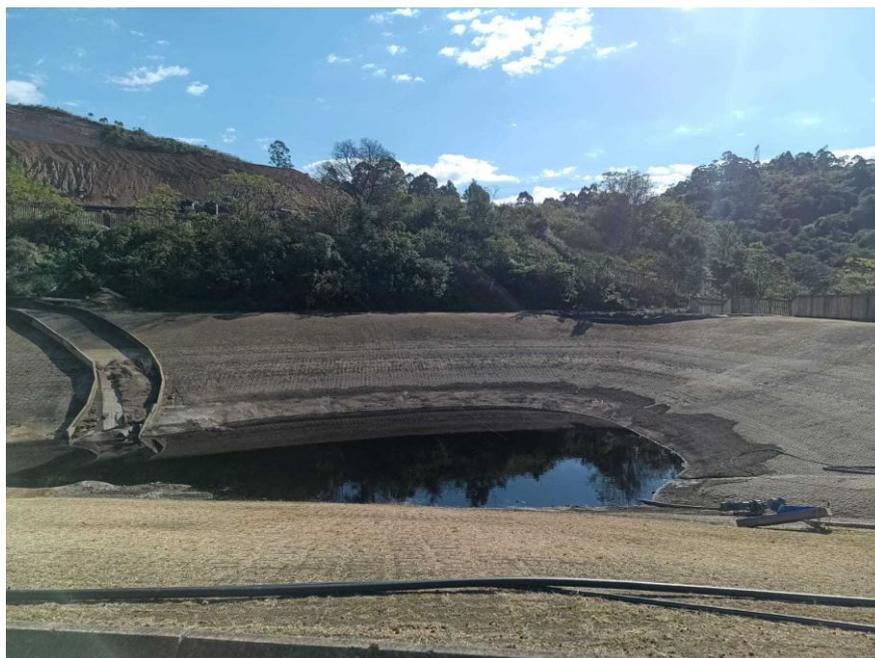
**Plate 2: Contaminated storm water collection pond. Valley 2**

Contaminated storm water collection facilities meet the stated requirements and can handle the runoff of a one in fifty year storm event. Please see **Plate 2** of the one of the contaminated storm water ponds that collects and stores contaminated storm water generated on site. Contaminated storm water is trucked via road tanker to the Southern Waste Water Treatment Plant. Please see **Appendix D** for the permit to discharge the contaminated storm water.

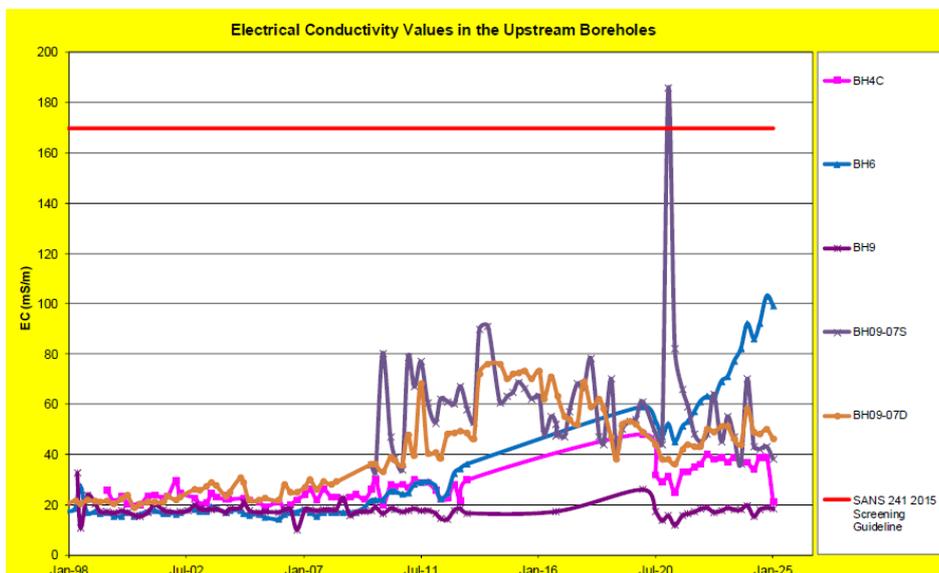
**Figure 1: Electrical Conductivity values within the upstream boreholes at the site**

The upstream boreholes are generally characterised by low EC values (Figure 1), ranging between 18 mS/m and 99 mS/m in January 2025. Borehole BH6 is characterised by an increasing EC trend. Since the borehole is located on a watershed, the reason for the increase is not known.

However, BH6 is characterised by a higher chloride and lower sulfate component compared to the other upstream boreholes. This may indicate an impact from the waste body where low oxidation-redox potential (Eh) of the leachate has resulted in a reduction in the sulfate concentrations while the chloride remains unaffected and

accumulates leading to the increased EC. Future trends within this borehole should be reviewed.
